August 2008

Cumberland Valley Rail Trail

Newville to Carlisle Link
Preliminary Corridor Assessment

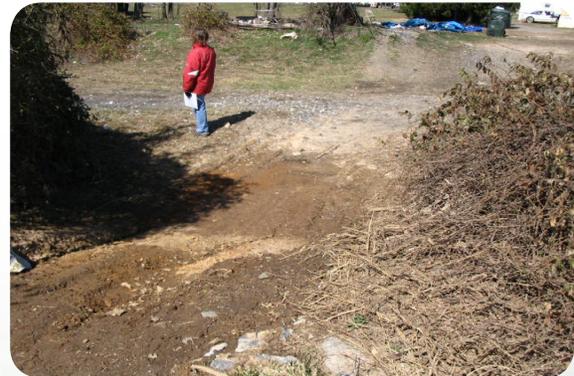
The rail bed from the mobile home park to the Garrity property is used and criss-crossed by off-road vehicles. The rail bed is weedy and with some brush. No other limitations on the general condition/suitability of the corridor for a potential trail were observed from Allen Road to the eastern limits at the Garrity property.

Off-road vehicle damage

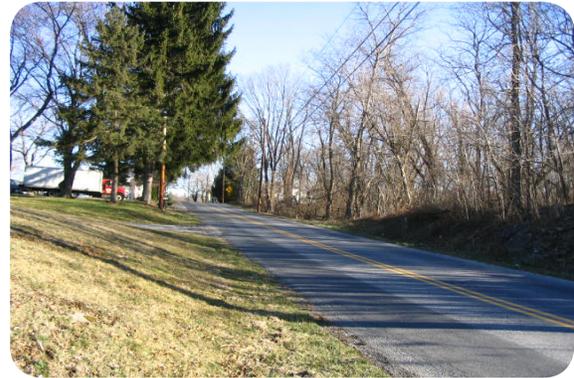
Sight distance on the west side of the road appears to be adequate, however there is some bedrock to the south that could obstruct the required sight distance.

Sight distance looking north along west side of
McAllister Church Road

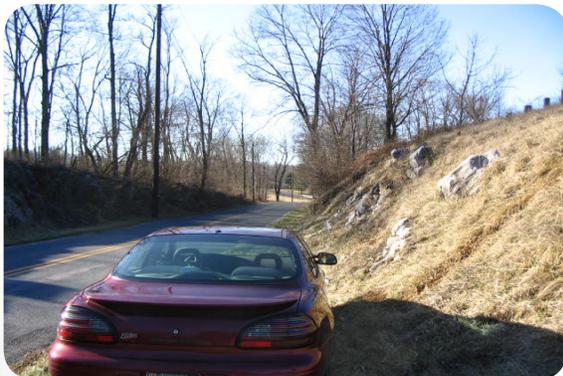
Sight Distance looking south along west side of
McAllister Church Road

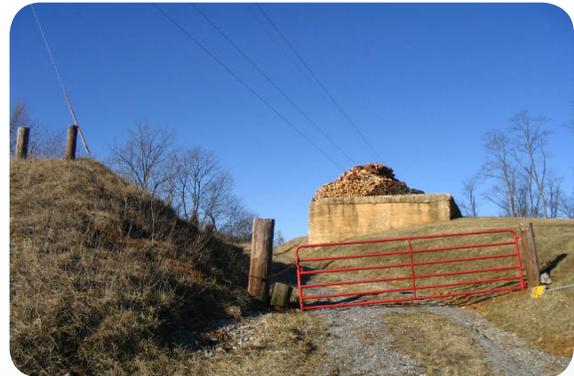
The slope of the driveway to the west varies from twelve (12) to fifteen (15) percent. A concrete structure is located to the immediate north of the driveway and is currently used as a platform for stacking firewood. This structure does not appear to be a part of PPL's property. It needs to be noted that the location of the concrete structure and the tower and guy wire on the immediate west side of the road could pose an obstruction for the grading required to meet ADA requirements. Due to the visible rock outcrops and the location of the tower and the guy wire, this crossing may, if access is granted by Garrity at some time in the future, be a good candidate for a pedestrian bridge.

Guy Wire/Firewood Platform

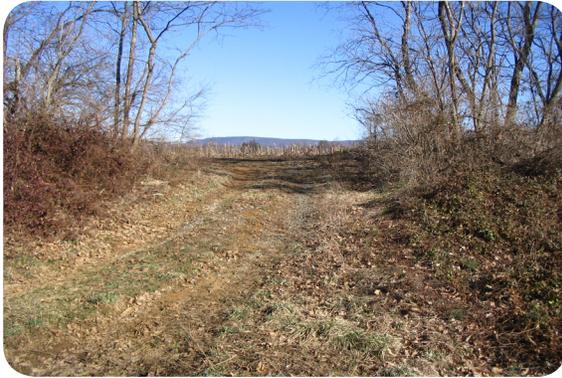
There is a well used farm crossing located nearly mid-way between McAllister Church Road and Greason Road. The trail would need to be built to accommodate this crossing. Storm water culverts may be required to maintain the flow of storm water along this portion of the rail bed.

Farm crossing looking north

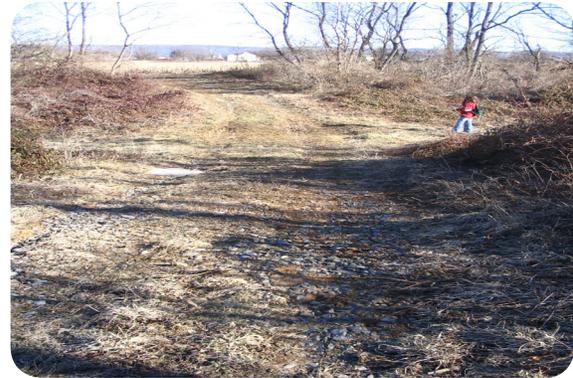
Farm crossing looking south

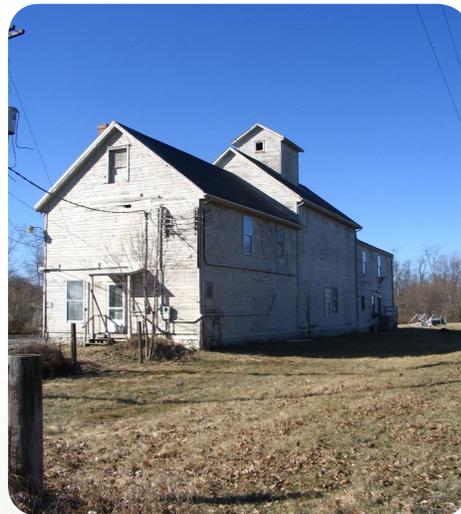
There is a 2 ½ plus story structure on the west side of Greason Road adjacent to the south side of the rail bed. It appears to be an old siding station that was converted to residential use, but it appears unoccupied.

Vacant Structure west side of Greason Road

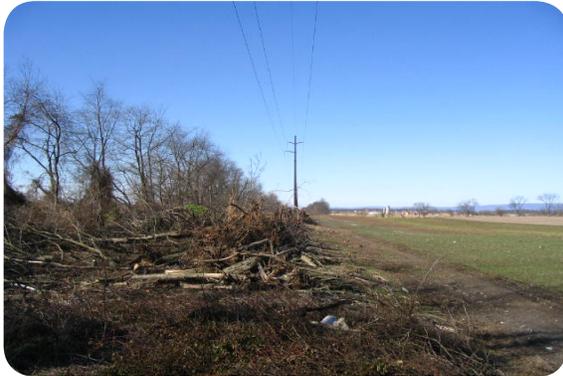
The area from the end of the second farm west of Greason Road through to Springview Road has been severely compromised. A portion of the tree line along the north side of the rail bed was cleared and the stumps and debris were pushed onto the ballast area of rail bed. There have been many piles of field stone dumped under the power lines along the rail bed. Closer to Springview Road, there is an active, recently burned, farm dump on the rail bed. The farm dump will need to be cleared/closed in accordance with applicable DEP's solid waste management requirements.

Trees/debris west of Greason Road

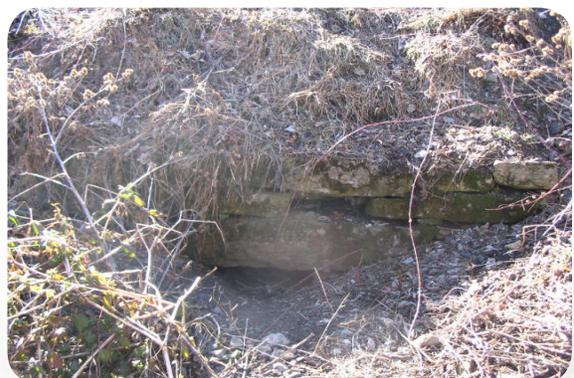
There are several stone culvert headwalls visible on the north side of the rail bed. There is no evidence of culverts on the south side. The above mentioned field stone may have been pushed down over the south side of the rail bed and most likely buried and/or obscured them. The need for these culverts will need to be further evaluated and if necessary, they will need to be cleared/repared or replaced.

Stone Culvert (typical)

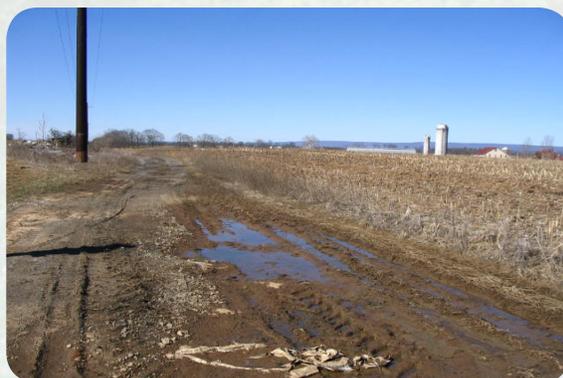
Debris/Drainage

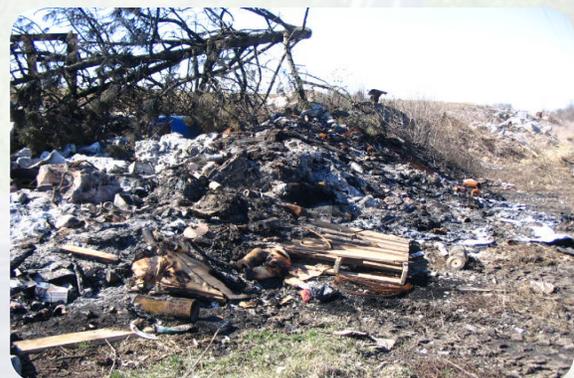
Active Farm Dump

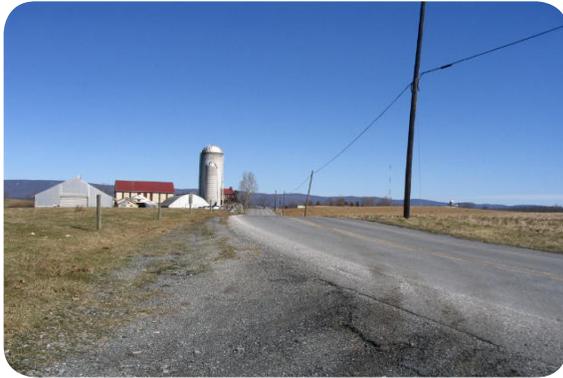
Sight distance along the east side of the road looking south appears adequate. The sight distance to the north is blocked by the fill that was placed to build the railroad. There are no PPL towers in this immediate vicinity. Sight distance should be able to be obtained by removing a portion of the railroad fill. Sight distance along the west side of the road looking south is partially obstructed by brush and a small tree. With minor brush clearing, adequate sight distance should be able to be obtained. The sight distance to the north appears adequate although the impact of a dip in the cartway of Springview Road north of the rail bed will need to be further evaluated.

West side of Springview Road, looking north,
note DIP in road

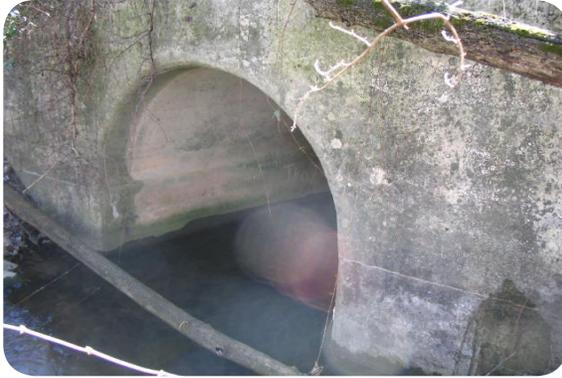
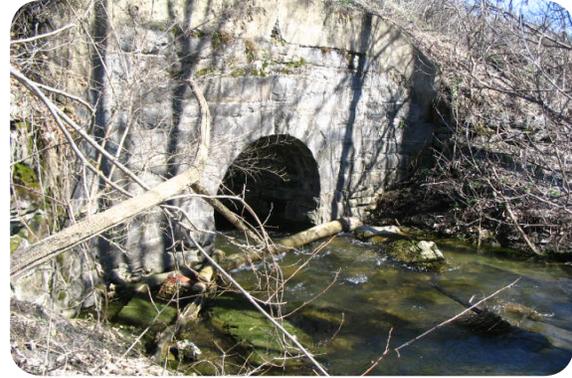
Stone/Concrete Arch Culvert

Approximately two hundred (200) feet west of Springview Road, Mount Rock Spring Creek passes under the rail bed through a concrete/stone arch culvert. The flow is from south to north. The north side is a concrete arch culvert with no evidence of spalling or undermining. The south side is a cut stone arch with a concrete cap. Minor deterioration of this concrete was observed but overall appears to be in good condition. The culvert appears to be cut stone for approximately half it's distance from south to north. The interior of the structure looks sound at the south side with no evidence of undermining of the wing walls or the abutments but this could not be verified. The stone work will require minor re-pointing. Vegetation is starting to encroach upon the structure and should be cleared/removed to prevent further penetration into the structure.

North side of Stone/Concrete arch culvert

South side of Stone/Concrete arch culvert

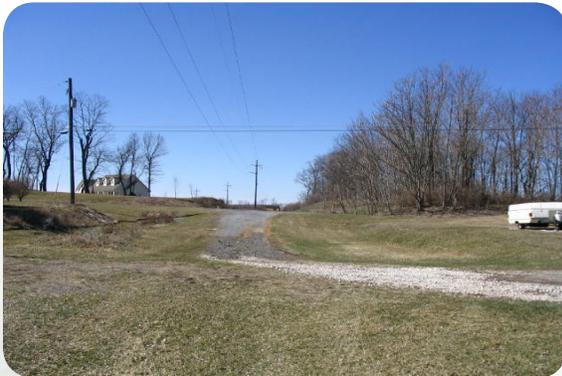
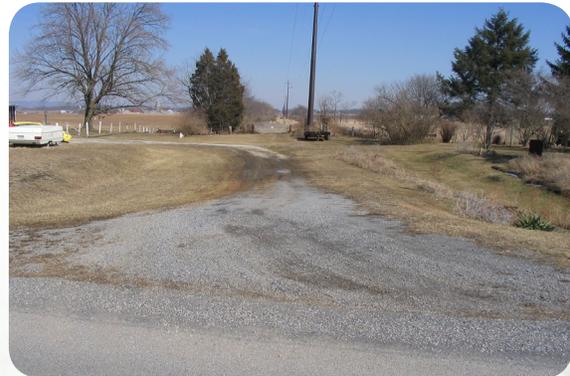
The residents of the dwelling on the east side of Kerrsville Road and the north side of the rail bed appear to use the rail bed as part of their driveway. They have a U-shaped driveway with a second access to Kerrsville Road north of the rail bed. There also appears to be a seldom used crossing from the Cornman property on the south side of the rail bed to the dwelling located north of the rail bed.

Approach from the east side of Kerrsville Road,
note driveway

From Kerrsville Road looking east, note driveway

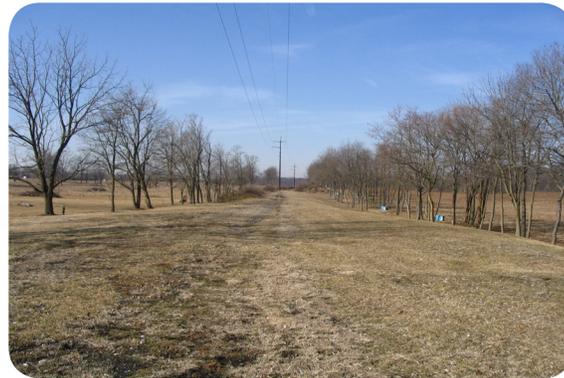
The rail bed in the area immediately west of Green Hill Road is regularly mowed and maintained. A private target (shooting) range is located along the north side of the rail bed, west of Green Hill Road. There are bench rests, and at least three (3) target backstops. This will conflict with the use of the rail bed as a trail. The area west of the shooting range is maintained but not to the level of the area immediately west of Green Hill Road. The Wax farm, a county preserved farm, adjoins the north side of the trail, east of Mount Rock Road. The agricultural conservation easement will not allow granting any easement or right-of-way for a trail.

Looking west from the west side of Green Hill Road, note shooting range on right

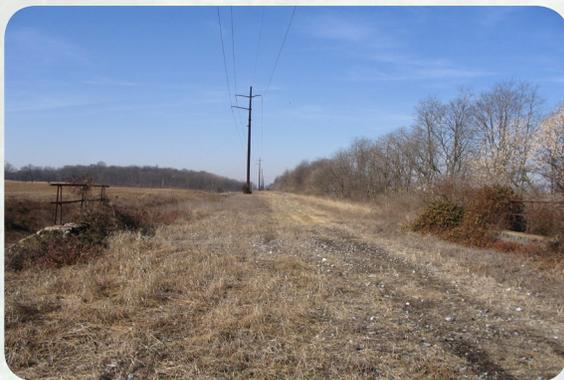
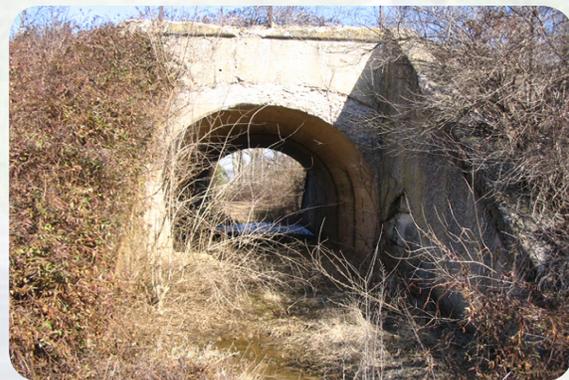
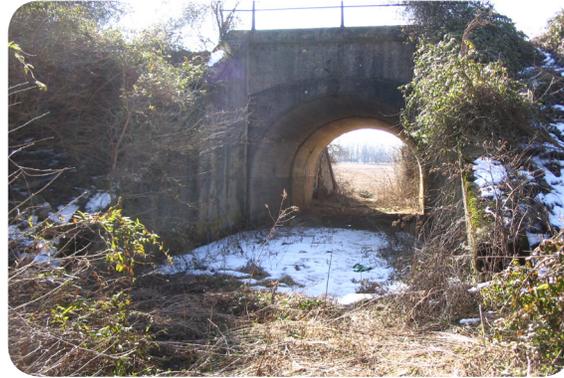
Approximately three hundred and fifty (350) feet west of Green Hill Road, a large drainage area flows from south to north under the rail bed through a fourteen (14) foot by twelve (12) foot arch stone and concrete culvert. No active flow was observed during our evaluation. There is evidence of minor seepage throughout the structure and minor concrete spalling. There is a portion of the southeast wing wall where the concrete parget has deteriorated and exposed the original cut stone of the structure. The wingwalls on the north side of the culvert are much more stable with very minor spalling. Vegetation is starting to encroach upon the structure and should be cleared/removed to prevent further penetration into the structure. The hand railings are intact on both sides.

Stone/Concrete Arch Culvert looking west to Mount Rock Road

South side of Culvert west of Green Hill Road

North side of Culvert west of Green Hill Road

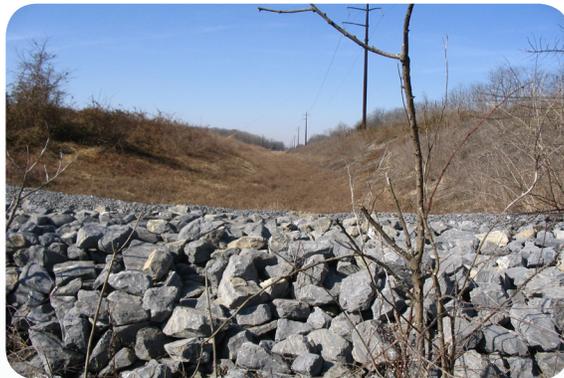
There is what appears to be a detention facility/diversion channel located at the southwest corner of the culvert. It extends from the culvert west along the rail bed to Mount Rock Road.

Detention Facility/Diversion Channel east of Mount Rock Road

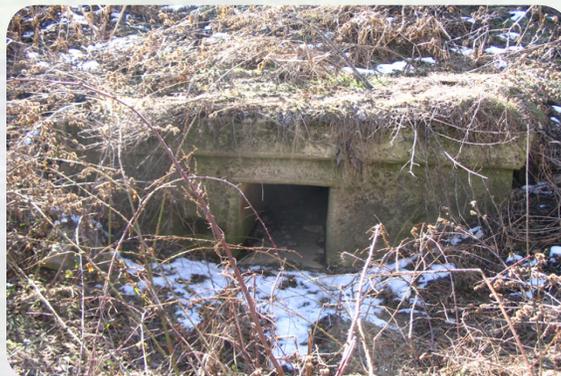
There is an approximately twenty four (24) inch by twenty four (24) inch stone and concrete box culvert just east of Mount Rock Road. The culvert is partially obstructed in the middle but is open all the way through. Flow appears to go from north to south and discharge into the diversion channel on the south side of the rail bed.

24" x 24" Stone/Concrete Culvert east of Mount Rock Road

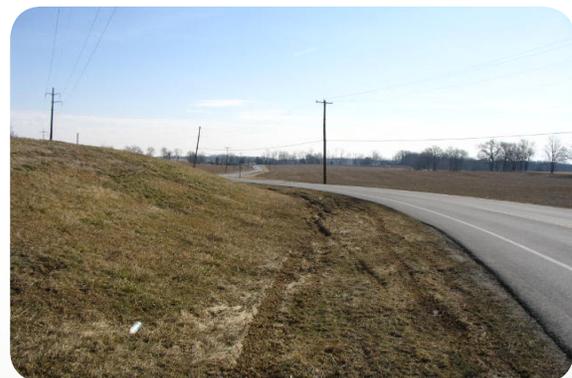
Along the east side of Mount Rock Road, sight distance to the north is unobstructed to a point north of the entrance to the Big Spring High School campus. Sight distance to the south is partially obstructed by the embankment of the rail bed. Minor grading should correct the sight distance deficiency.

East side of Mount Rock Road looking south, note partial sight distance obstruction by embankment

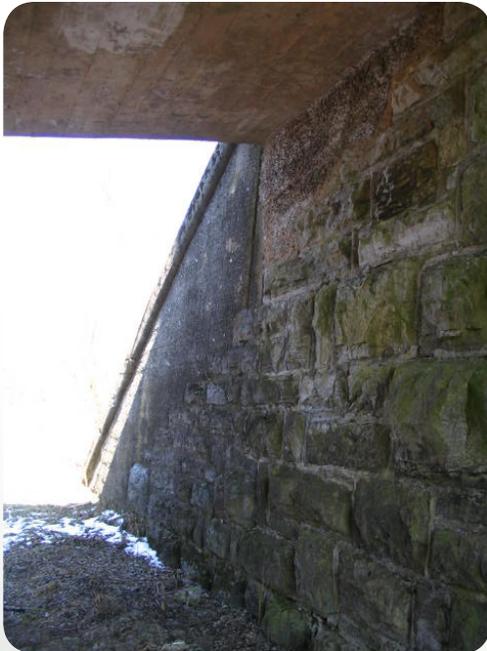
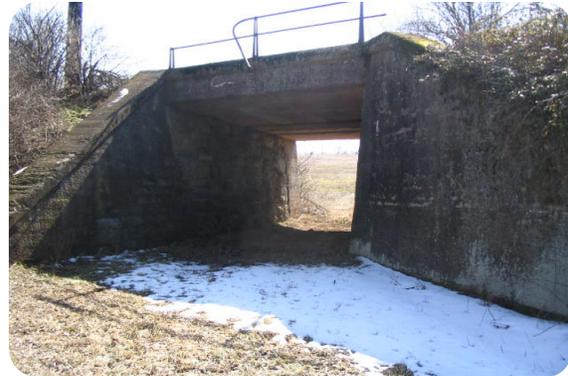
Approximately five hundred and fifty (550) feet west of Mount Rock Road, a large drainage area flows from south to north under the rail bed through a thirteen (13) by twelve (12) foot culvert at an approximately fifteen (15) or twenty (20) degree skew from the rail bed alignment. There is evidence of minor seepage throughout the structure and minor concrete spalling on the bottom of the deck with some rebar exposed at various places.

The wing walls are a combination of cut stone capped with concrete and concrete. The handrail on the north side of the culvert is damaged and will need to be repaired. There was one (1) sanitary sewer manhole found (by Stephanie Williams) in the approximate center of the north side of the culvert. Vegetation is starting to encroach upon the structure and should be cleared/removed to prevent further penetration into the structure.

South side of Stone/Concrete Culvert west of Mount Rock Road

North side of Stone/Concrete Culvert looking south

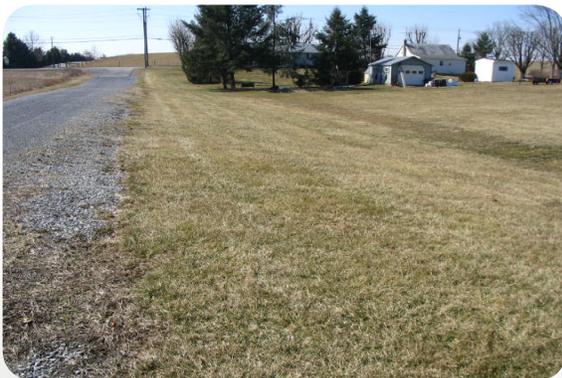
Access from the PPL substation property could be provided via an existing graded driveway at the north east corner of the property intersecting with the rail bed approximately two hundred (200) feet east of the last tower of the transmission line. Perpendicular parking for ten (10) to fifteen (15) cars could be provided along the north side of the substation access drive. Screening of the adjoining residential properties would be appropriate for this parking area.

Potential Parking Area at PPL substation access drive
