# NeWPeC Feasibility Study/ Master Plan

## The Newville to Carlisle Extension of the Cumberland Valley Rail Trail

Prepared by

June 2013

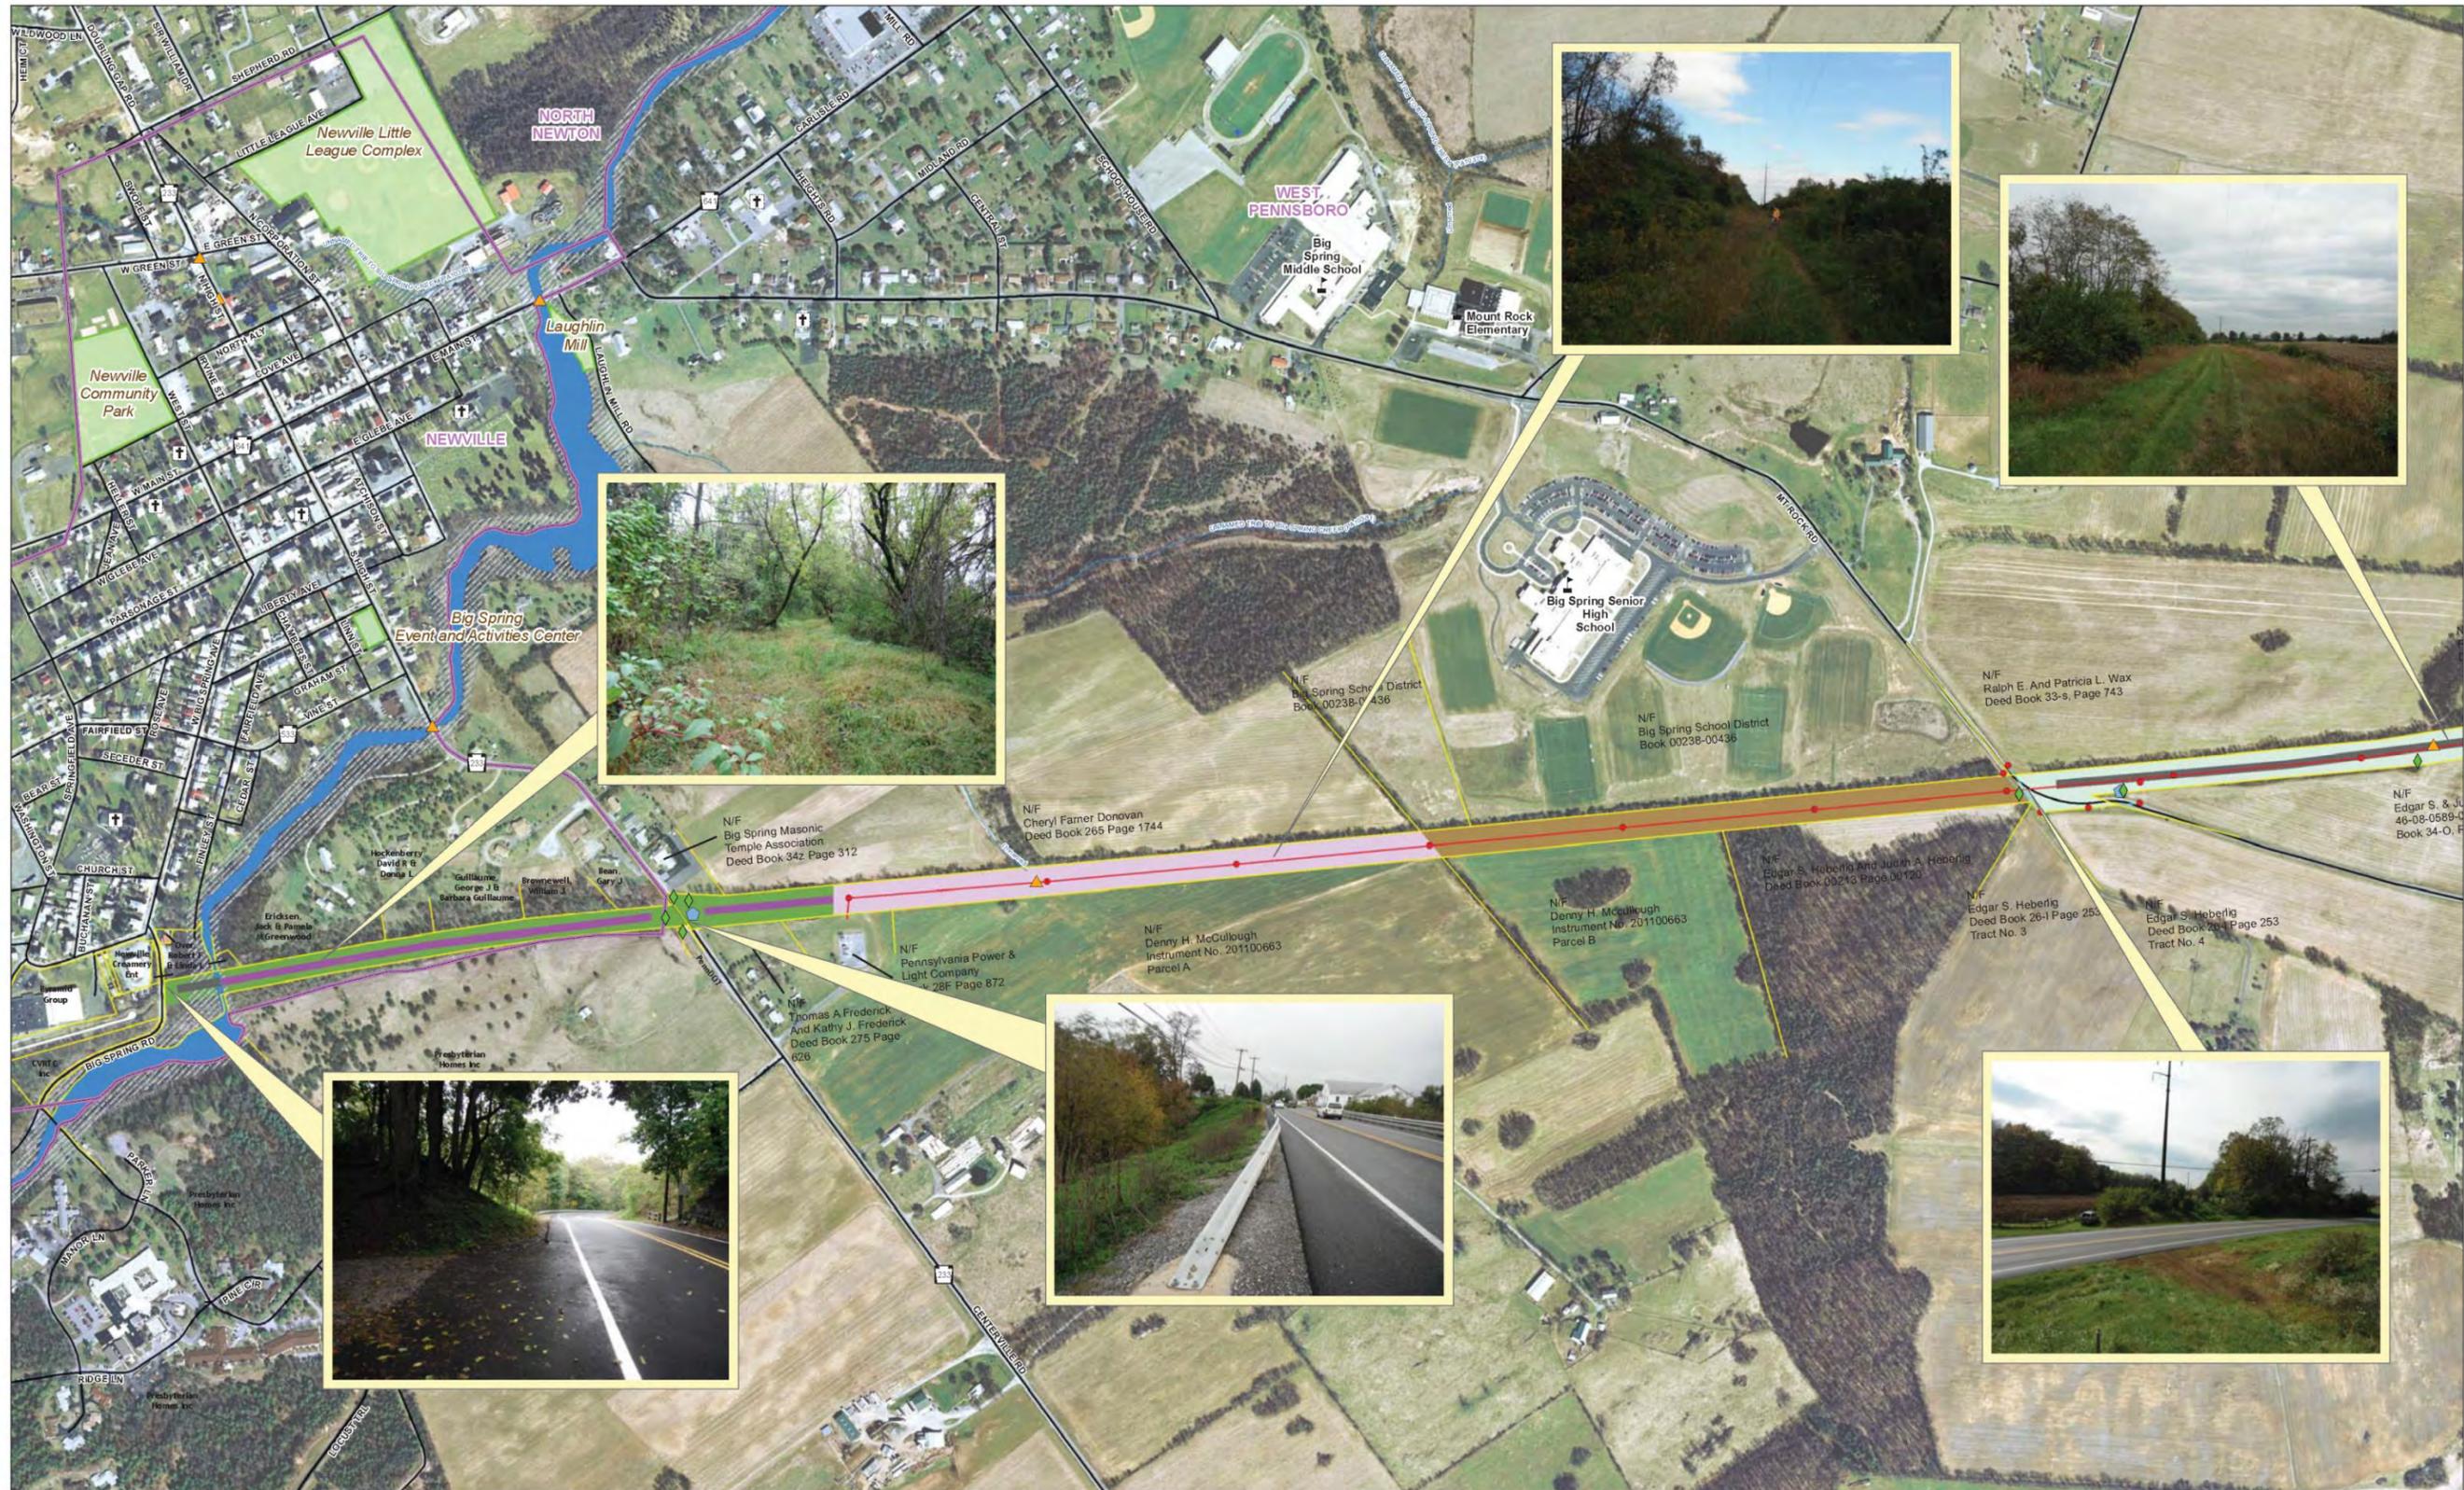
**CVRTC NeWPec Master Plan**  
**Map 3: Existing Natural and Cultural Features**  
 Sheet 1 of 5

Aerial photos of existing field conditions are shown on the Natural and Cultural Features Maps following this section.

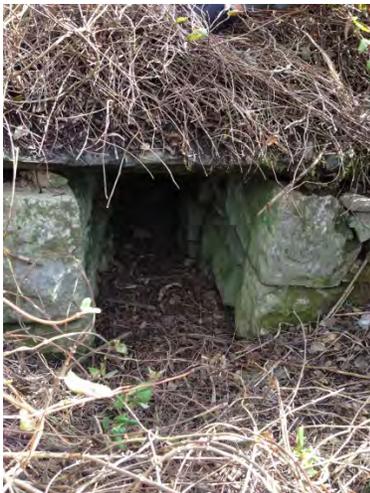
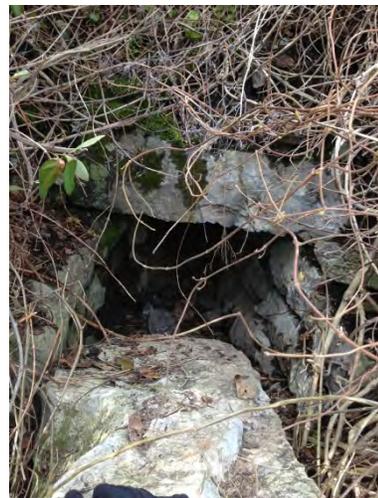
### Pictures:

#### Deterioration Noted During Visual Inspection:

1. Work with private property owner to excavate and reset culvert stones and cap stone on south side.
2. During construction of the rail trail, minimize the magnitude and frequency of heavy construction loads on the structure as much as possible.
3. As construction proceeds over and around the structure, monitor the structure for any signs of distress caused by construction.
4. Removal of vegetation around the structure is recommended.
5. After the trail is open for use, periodically inspect the structure. Monitor the masonry portion of the structure for further shifting.
6. During construction, perform excavation and backfilling evenly in the vicinity of the structure to prevent the structure from being loaded unevenly.
