# Agricultural BMP's for the Bore Mill Run Watershed

Funded by [Pennsylvania's Growing Greener Program](#)

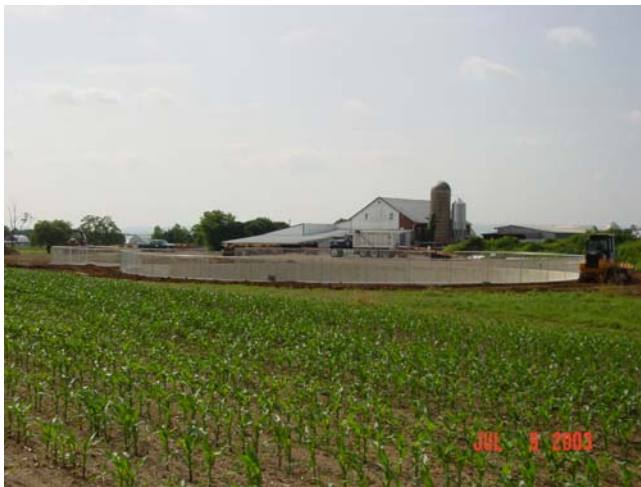
*Newly Installed Waste Storage Structure*

One of the BMPs that were implemented was a Manure Storage Facility. Utilizing a manure storage facility enables the farm operator to apply the manure at a time when the crops will readily use the manure and when weather permits. Conserving nutrients in this manner benefits water quality and allows the farmer to purchase little or no additional fertilizer which saves them money.

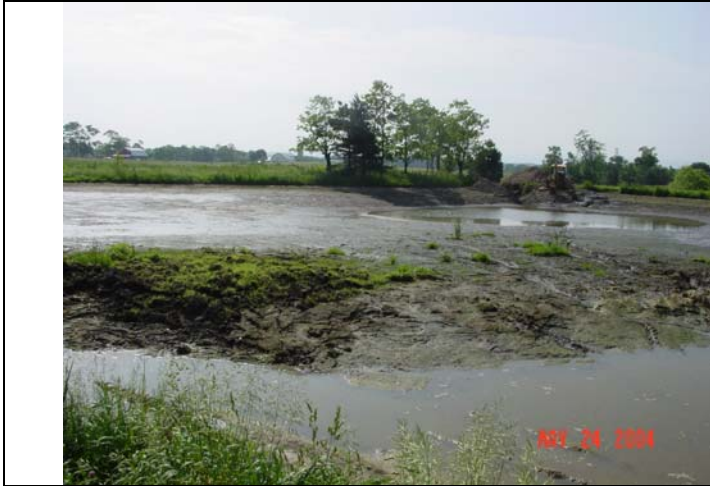
Before: Sediment and Nutrient Buildup in Pond

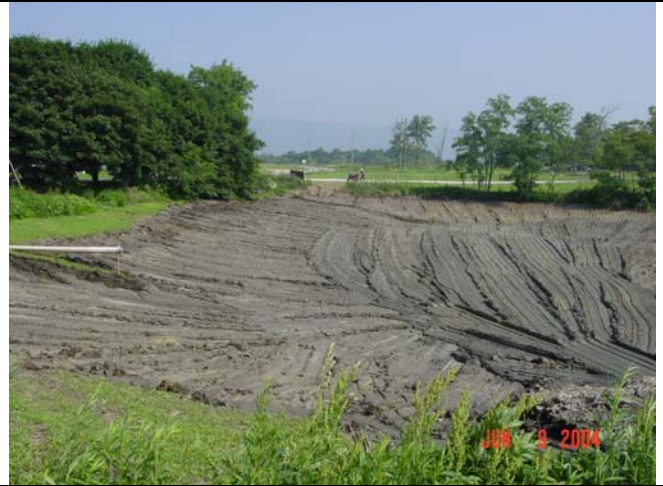
After: View of Pond Base Nutrient Removal

Approximately 1450 tons of nutrient rich material was removed from the pond during the cleanup process. A representative sample was tested to determine the actual nutrient content. \*\*From the sample analysis, the amount of nutrients removed from the water source could be determined.

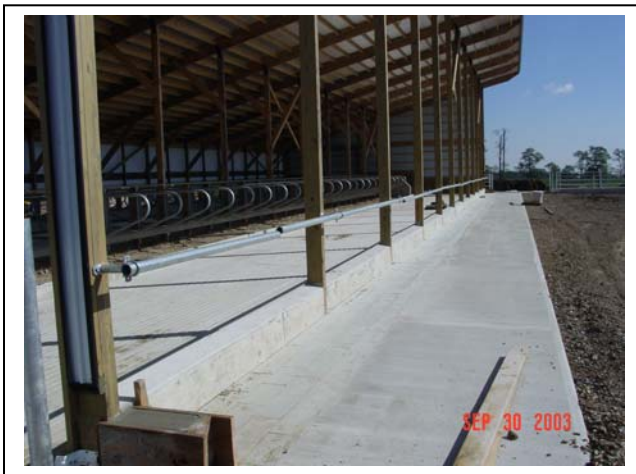
Concrete flooring was poured at heavy use areas

Manure runoff from animal concentration areas (areas where animals spend a lot of time) also needed to be managed to prevent contamination. There were multiple BMPs that were installed including: barnyard roof runoff management, surface water controls, runoff controls, and heavy use area protection. Due to the large scale of the project, additional funds from the USDA EQIP program and the PA Chesapeake Bay Program were allocated to assist with project implementation.

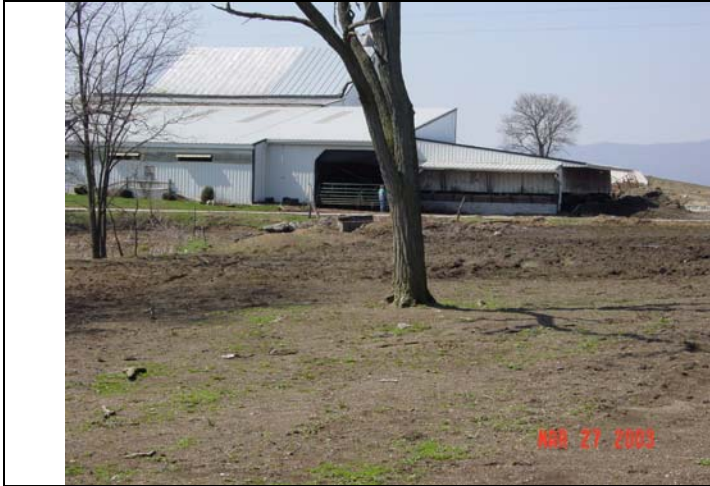
*\*Before: View of Denuded Pasture*

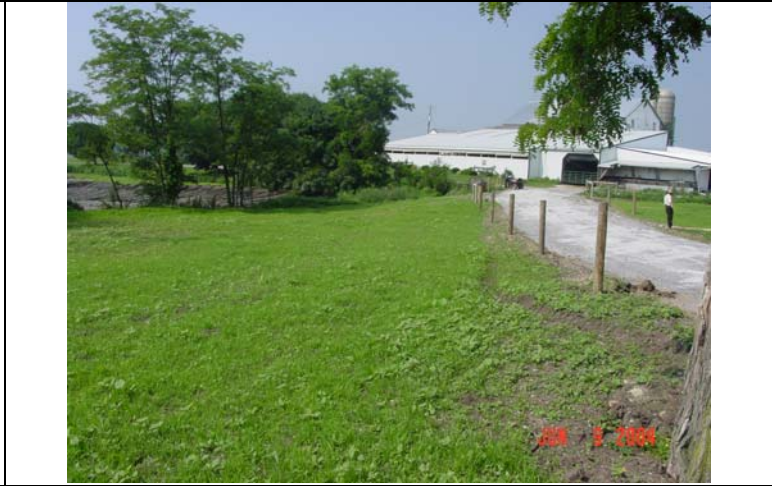
*After: View of New Grass Buffer and Walkway*
